MEMORANDUM

File Ref: A2272466

Subject: Ecological health of Waihi Estuary

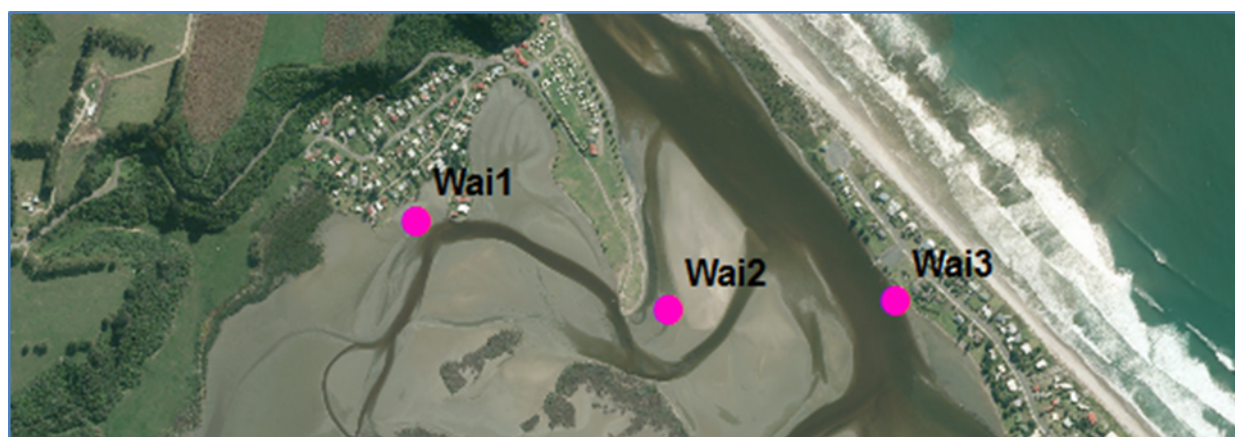
Three NERMN monitoring sites were set up in Waihi Estuary in the 1990s to assess the long-term state of the habitat and intertidal animal communities present (shellfish, crabs, worms etc.). Site 1 (Wai1) shown in Figure 7 is monitored on an annual basis while sites 2 and 3 were monitored for a shorter period and provide a baseline against which later comparisons can be made.

Figure 7: Estuarine macrofauna monitoring sites in Waihi Estuary (established 1990).
